**Inspection Report**  
**Minerals Regulatory Program**  
Report Date: December 28, 2006

**Mine Name:** Bingham Canyon  
**Operator Name:** Kennecott Utah Copper  
Rohan McGowan-Jackson  
P.O. Box 6001  
Magna, Utah 84044-6001

**Permit number:** M/035/002  
**Inspection Date:** Dec. 19, 2006  
**Time:** 9:00 AM

Check on the regrading of the Bingham Canyon dump and the Bonneville Crusher.

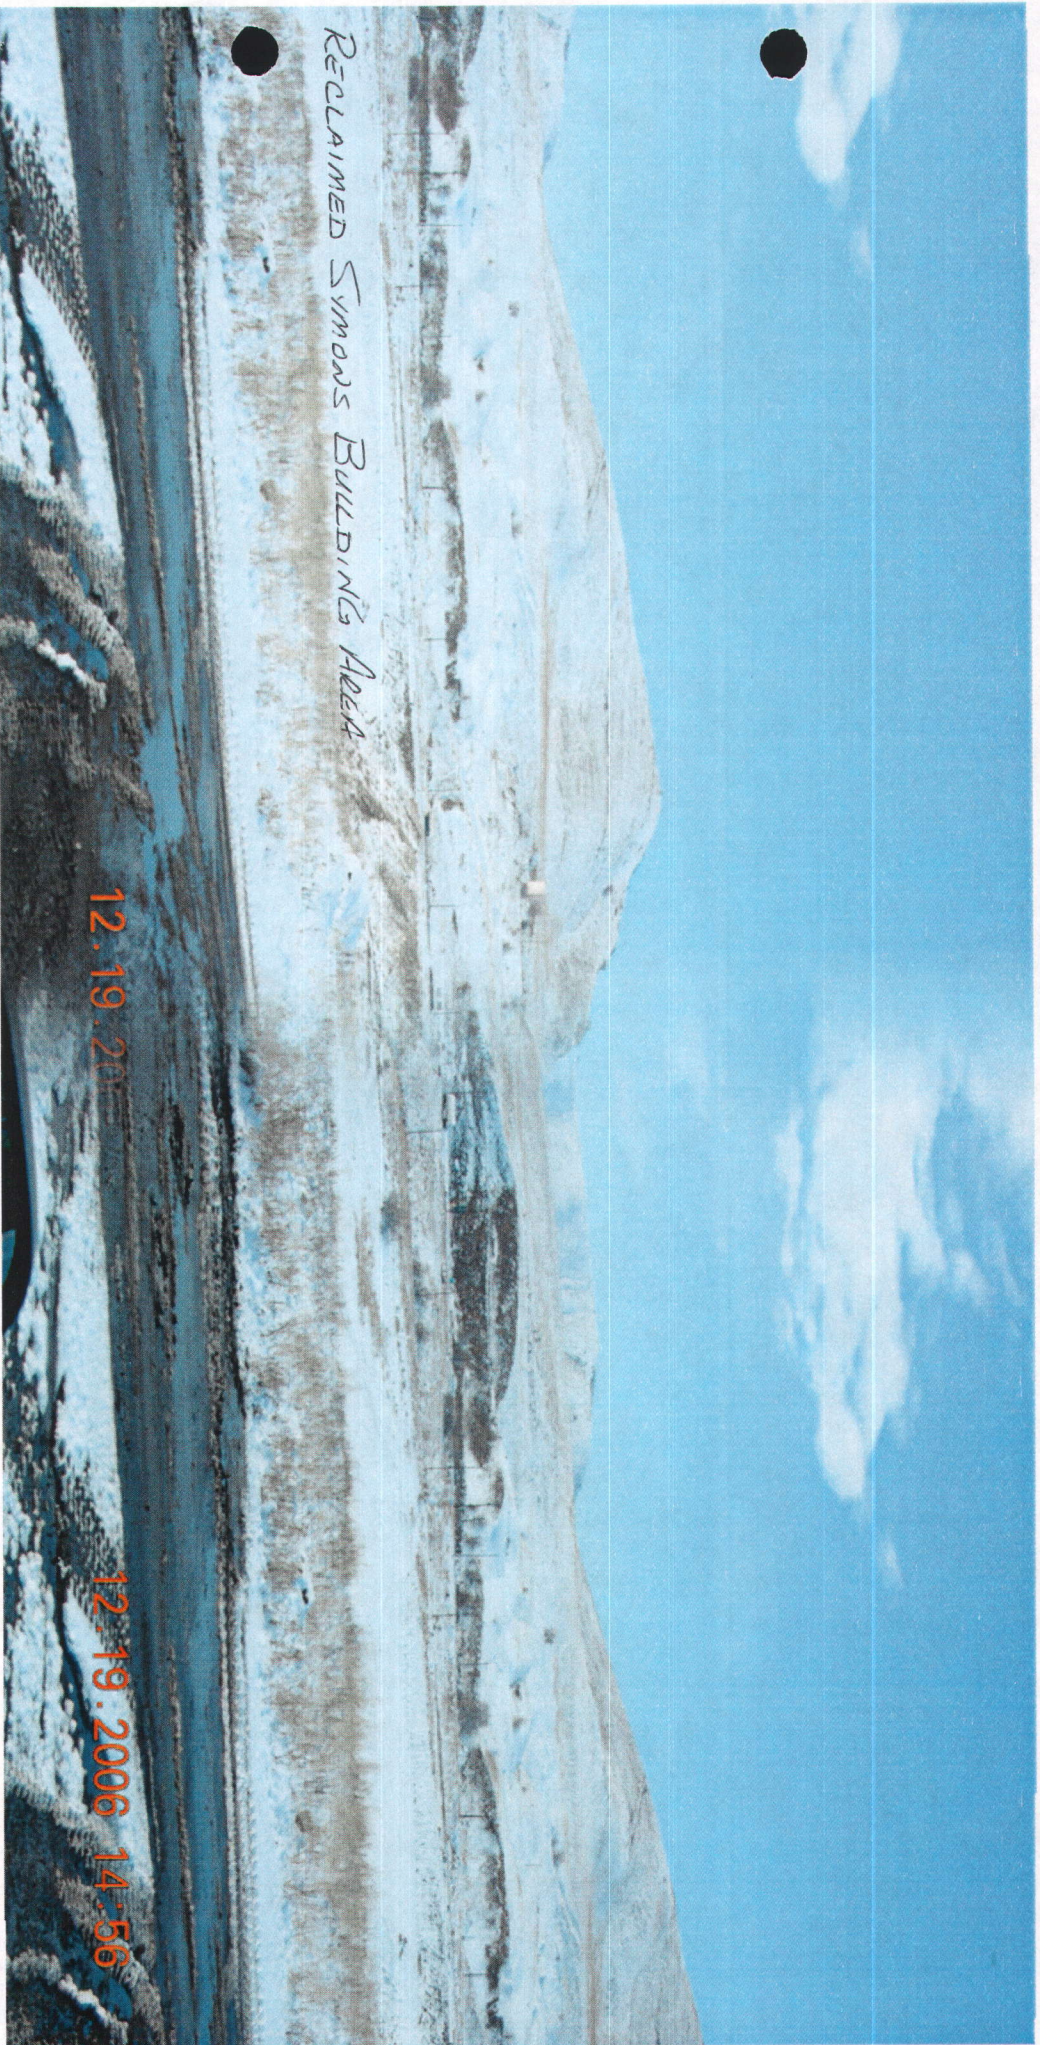
The Bonneville Concentrator was the next area visited. The recontouring of the area of the Symons building has been completed. The area still needs to be ripped and seeded in order to complete the reclamation of this portion of the site. A picture of this area is included with this report.

RECLAIMED SYMONS BUILDING AREA

BONNEVILLE CRUSHER  
SYMONS BUILDING AREA (IN FOREGROUND)
